DOT/FAA/AR-01/27

Engine Debris Fuselage Penetration Testing, Phase I

Final Report

6. Performing Organization Code NAWCWD 418300D	
7. Author(s) Steven J. Lundin				8. Performing Organization Report No.	
9. Performing Organization Name and Address Commander Naval Air Warfare Center Weapons Division 1 Administration Way China Lake, CA 93555-6001				10. Work Unit No. (TRAIS)

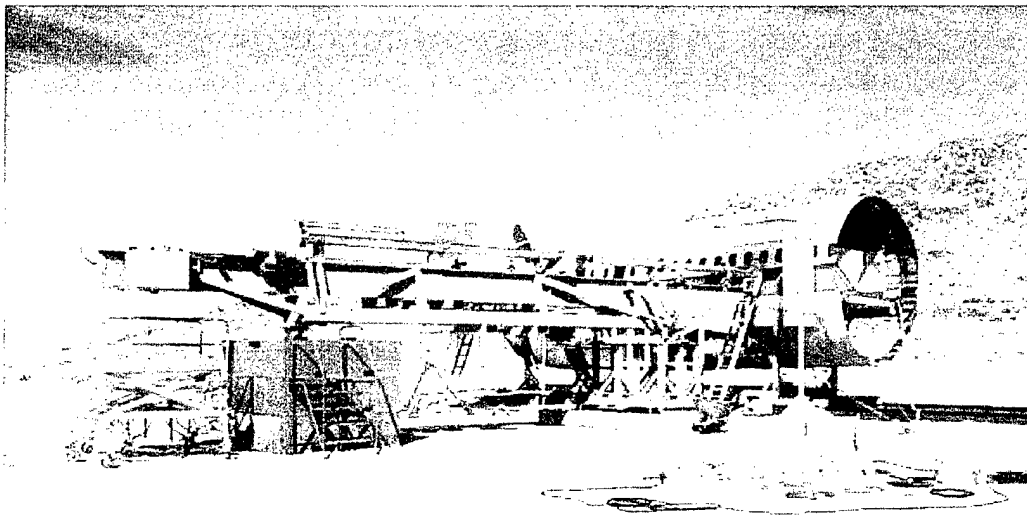
FIGURE 5. TEST SETUP SHOWING GAS GUN AND FUSELAGE

The test setup is shown in figure 5. The fuselage could be rolled ± 30 degrees and translated along a track to line up the different target areas. The gun had a limited elevation control and was typically close to horizontal and aligned with the upper radius of the fuselage section. Table 1 displays the fragment launch orientations and the shotline obliquities for each of the test shots. The fragment pitch angle was limited by the diameter of the gun and the sabot design. It was determined that with initial pitch angles of 15° the polystyrene foam in the sabot would fail randomly and result in spectacular fragment and sabot stopper plate impacts. For this reason most of the shots were at a reliable 0 degrees pitch.

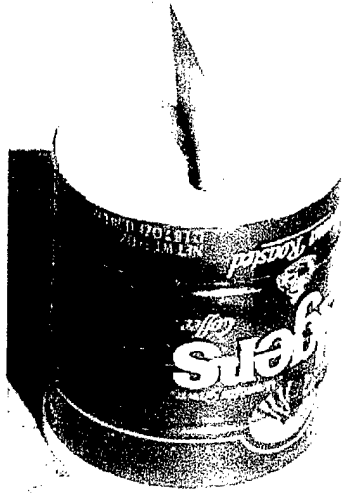
FIGURE 8. FINAL SABOT DESIGN WITH LOADED FRAGMENT

An example of the sabots can be seen in figure 8. A coffee can, Teflon, and Styrofoam to build the sabots were used. The Teflon was used as a backing plate to prevent the gas blast from destroying the foam. The coffee can had to be made slightly smaller in diameter to fit the gun, but worked wonderfully. The previous tests' sabot designs were very heavy and outweighed the projectile by many times. Stopping those sabots at the energies of this test was going to be expensive. Three sabot stopper plates of 3 in. Society of Automotive Engineers (SAE) 4140 steel were broken during the pretest experiments.

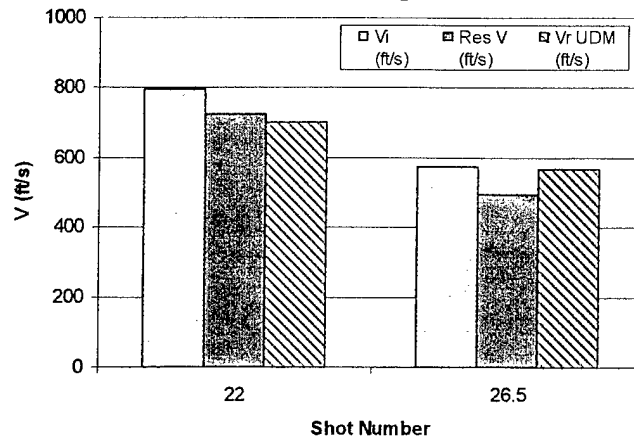
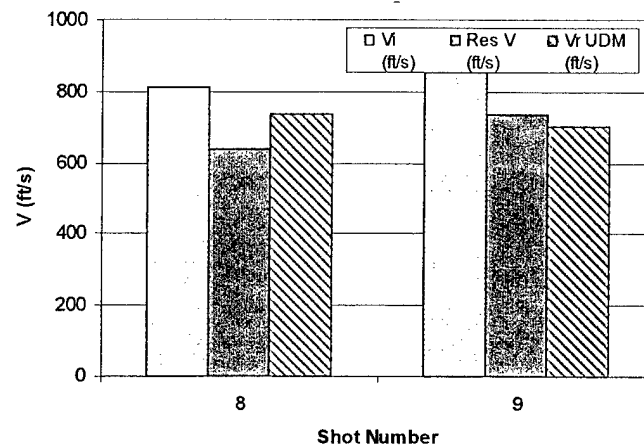
FIGURE 13. VELOCITY COMPARISON FOR IMPACTS INVOLVING SKIN ONLY

FIGURE 14. VELOCITY COMPARISON FOR IMPACTS INVOLVING SKIN RIB ELEMENTS

FIGURE 15. VELOCITY COMPARISON FOR IMPACTS INVOLVING SKIN AND HAT-STRINGER ELEMENTS

FIGURE 16. VELOCITY COMPARISON FOR IMPACTS INVOLVING SKIN AND Z-STRINGER ELEMENTS

FIGURE 17. VELOCITY COMPARISON FOR IMPACTS INVOLVING SKIN AND FUEL TUBING

Figures 13 through 17 show the results of the residual velocity comparisons for each of the structural combinations tested. In the figures, V_i is the impact velocity, Res V is the residual velocity from the high-speed film data, and V_r UDM is the residual velocity predicted with the penetration equations. Table 3 summarizes the shot results using the high-speed camera data. Table 4 summarizes the penetration equation results.

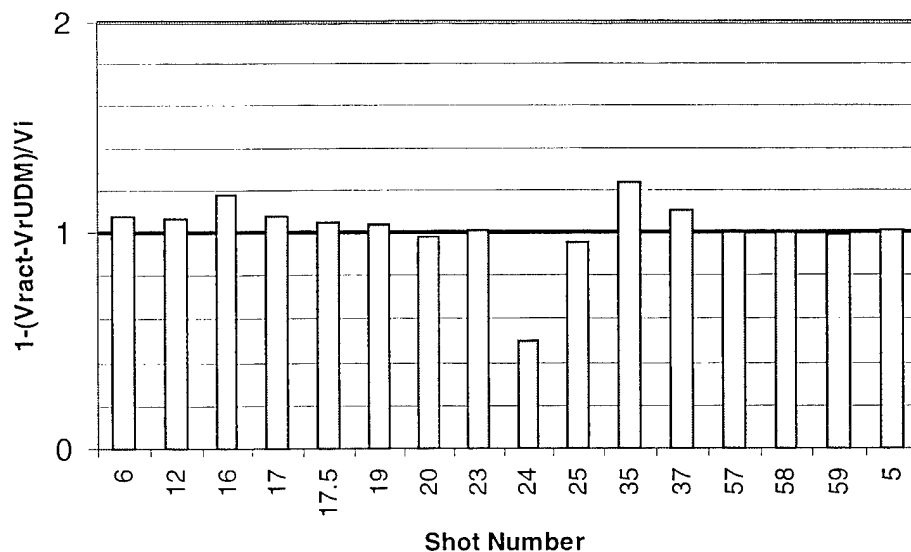
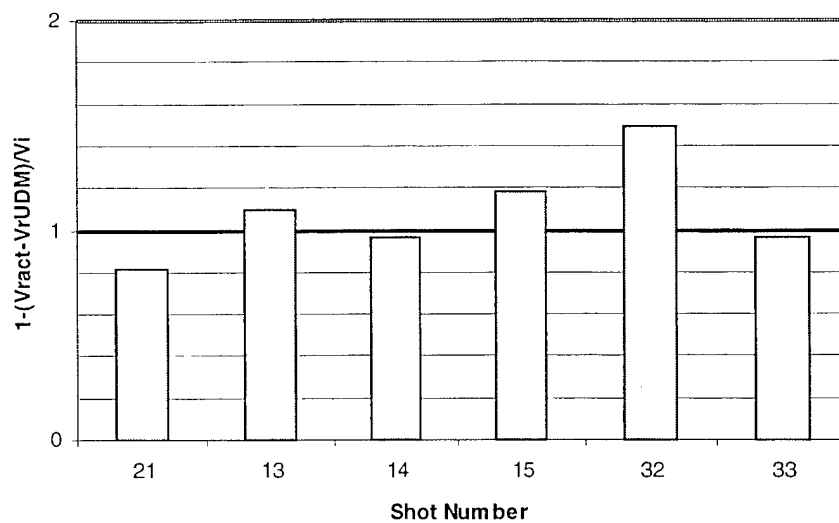
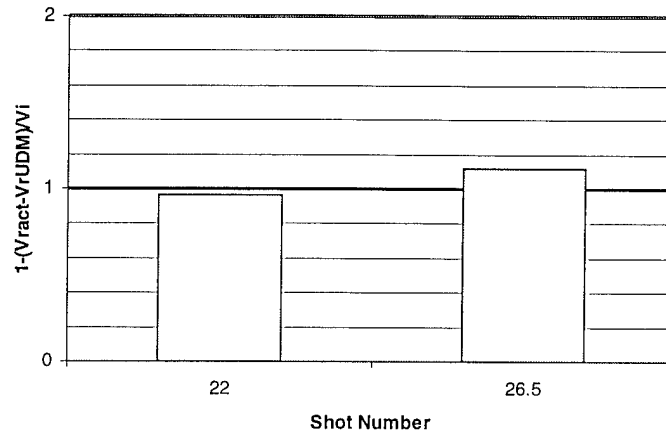
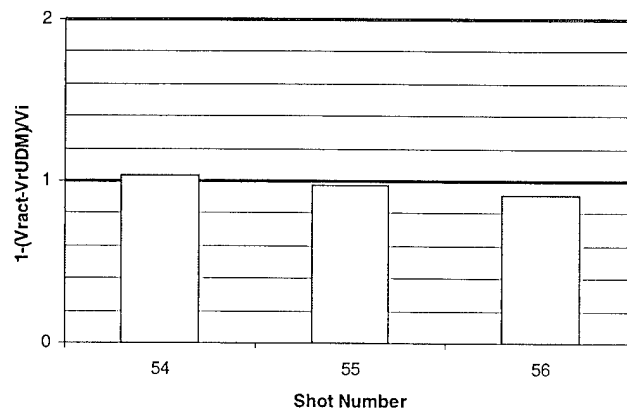
FIGURE 18. SKIN ONLY NORMALIZED RESIDUAL VELOCITY COMPARISON

FIGURE 19. SKIN AND RIB NORMALIZED RESIDUAL VELOCITY COMPARISON

FIGURE 20. SKIN AND HAT STRINGER NORMALIZED RESIDUAL VELOCITY COMPARISON

FIGURE 21. SKIN AND Z-STRINGER NORMALIZED RESIDUAL VELOCITY COMPARISON

FIGURE 22. SKIN AND FUEL TUBING NORMALIZED RESIDUAL VELOCITY COMPARISON

Figure 18 through figure 22 show the normalized residual velocities $(1-(V_{ract}-V_{rUDM})/V_i)$. A value of 1.0 indicates exact agreement between the penetration equations and the high-speed film data. These plots indicate a good agreement between the UDM methodology and the experimental results.

The above plots are presented for comparison to the previous test results documented in reference 1. Another way of looking at the problem is to ask how often do specific test cases agree when examining simple skin shots and more complex shots. This analysis shows a less favorable view of the methodology. Table 5 shows the relative agreements of the impact and residual velocities for three categories of shots. The skin and fuel tubing shots are presented as an indication that a modified methodology may be found that produces better agreements.

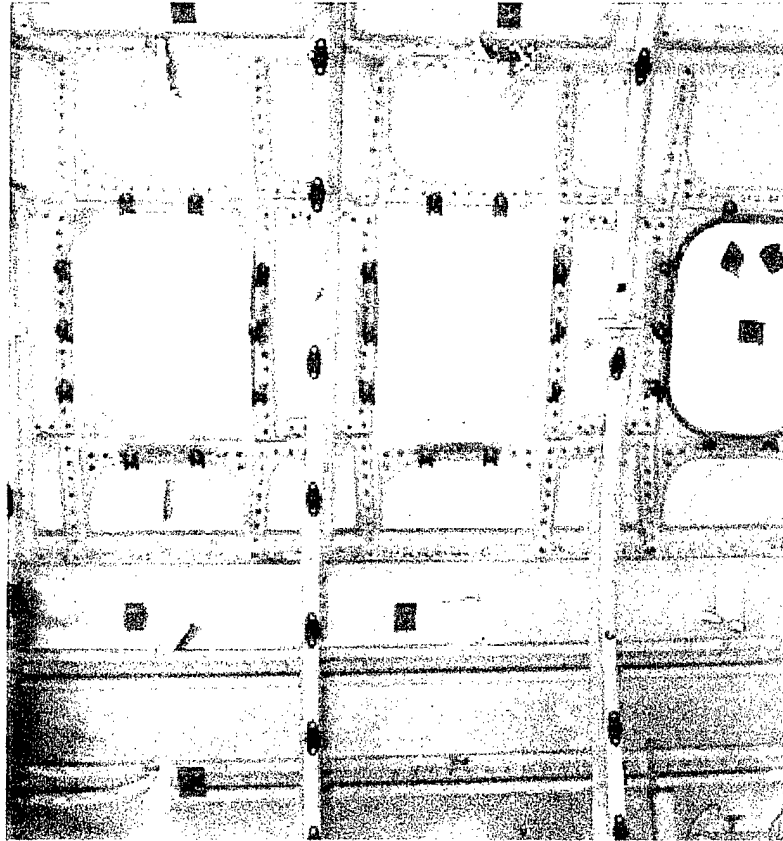
FIGURE 23. EXAMPLE EXTERIOR DAMAGE AREAS

FIGURE 24. EXAMPLE INTERIOR DAMAGE AREAS

Figures 23 and 24 show typical posttest impact areas from the inside and outside.
